PW4000-94 modification & upgrade programmes

The PW4000-94 has had several major upgrade & modification programmes. These are the Phase III programme, the more recent 'ring case' modification, and the withdrawal of a new HPT blade alloy. These improvements have led to a higher level of on-wing performance & reliability.

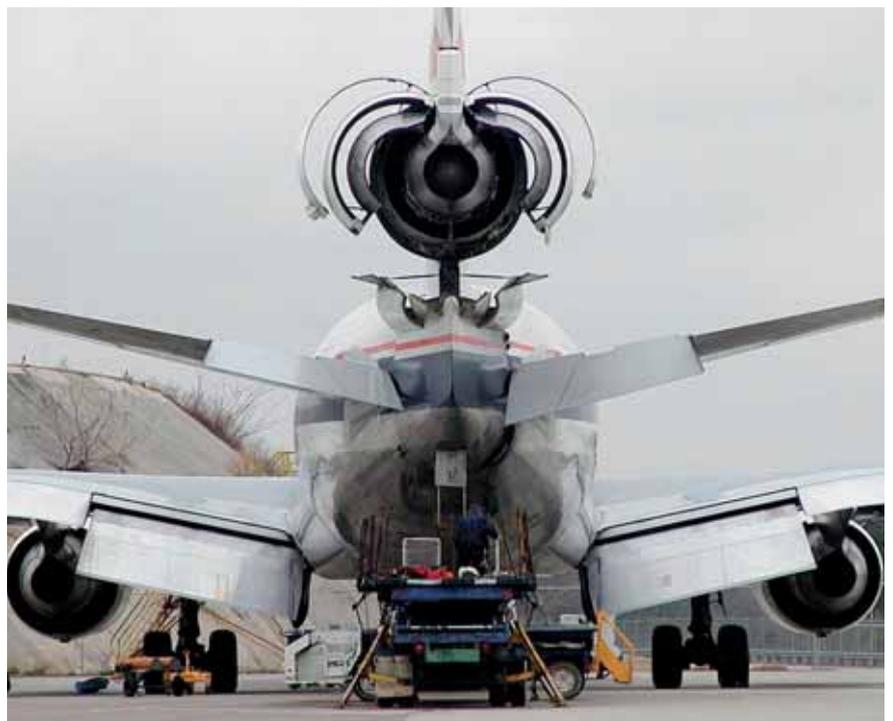
The Phase III programme was initially introduced in 1992 to address performance shortfalls of some MD-11 operations. The Phase III modification was subsequently used on the whole PW4000-94 fleet. The main features of the modification were improved fuel burn performance and increased EGT margin. About 950 of 1,100 Phase I engines have been modified.

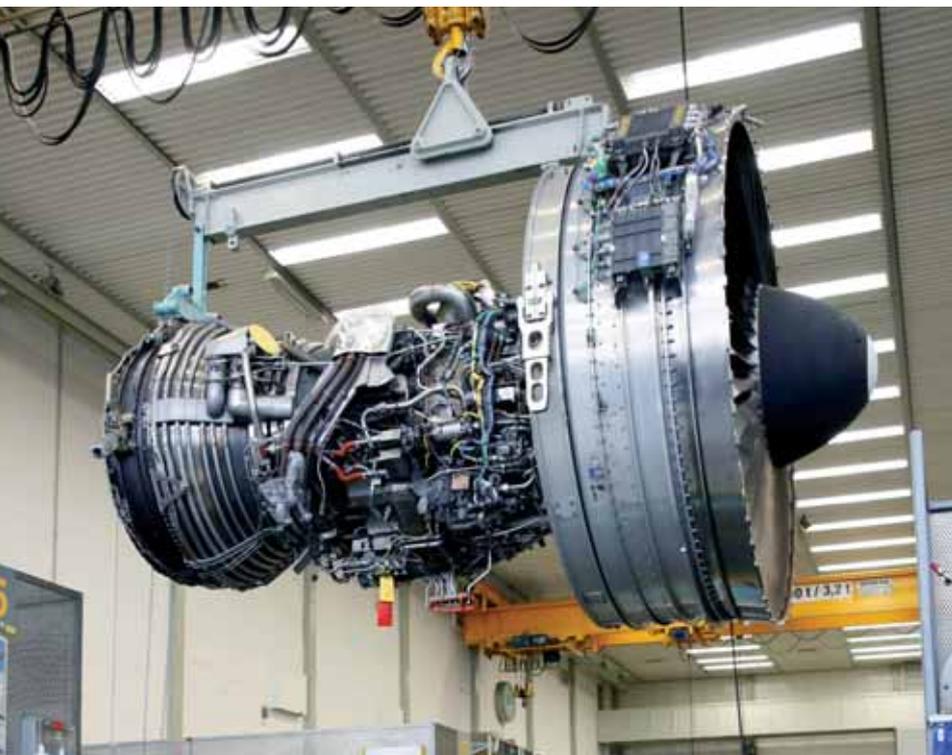
Part of the Phase III modification programme was the introduction of a new HPT stage 2 blade alloy. This was used to withstand the higher temperatures that Phase III engines run at. The unforeseen problems with the new alloy, however, was internal sulphidation and external cracking. This blade material has been withdrawn and the original blade alloy is now used.

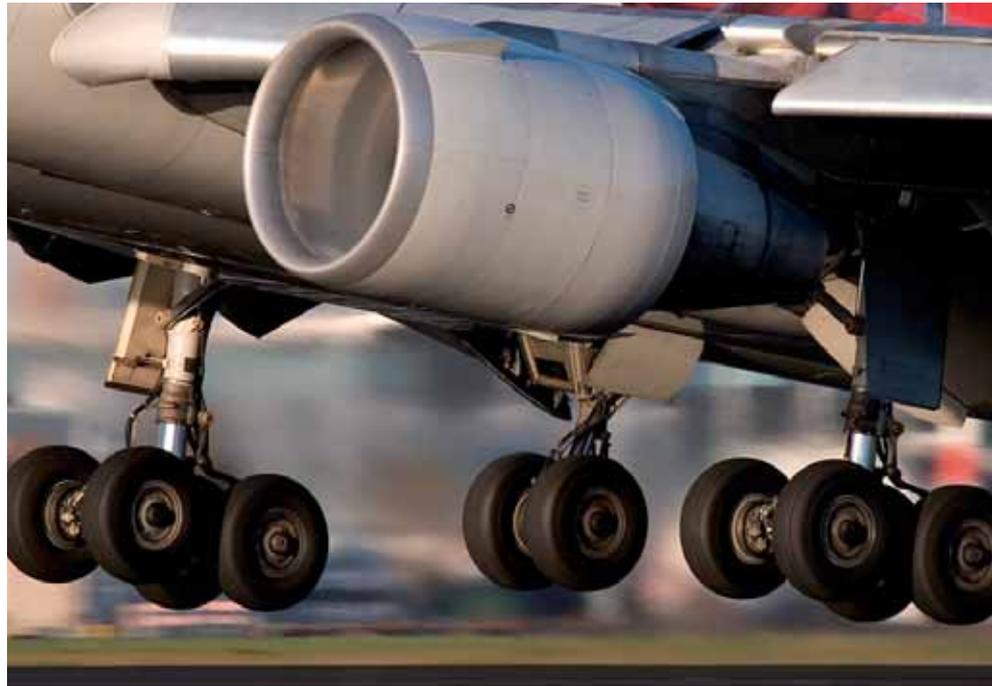
The PW4000-94 series suffered problems with HPC stalls and surges for about 10 years. This was due to wide blade tip-casing clearances in the HPC's latter stages. This has been cured by the 'ring case' modification. With this in place, many operators expect the engine to be capable of removal intervals of 20,000EFH or longer.
