The Service Bulletin detailing a modification to replace the window belt skins on 737-300s & -500s provides airlines with an option to avoid costly repetitive inspections and repairs. The modification is expensive, and if made mandatory could have serious implications for asset life.

737 Classic window belt skin replacement modification

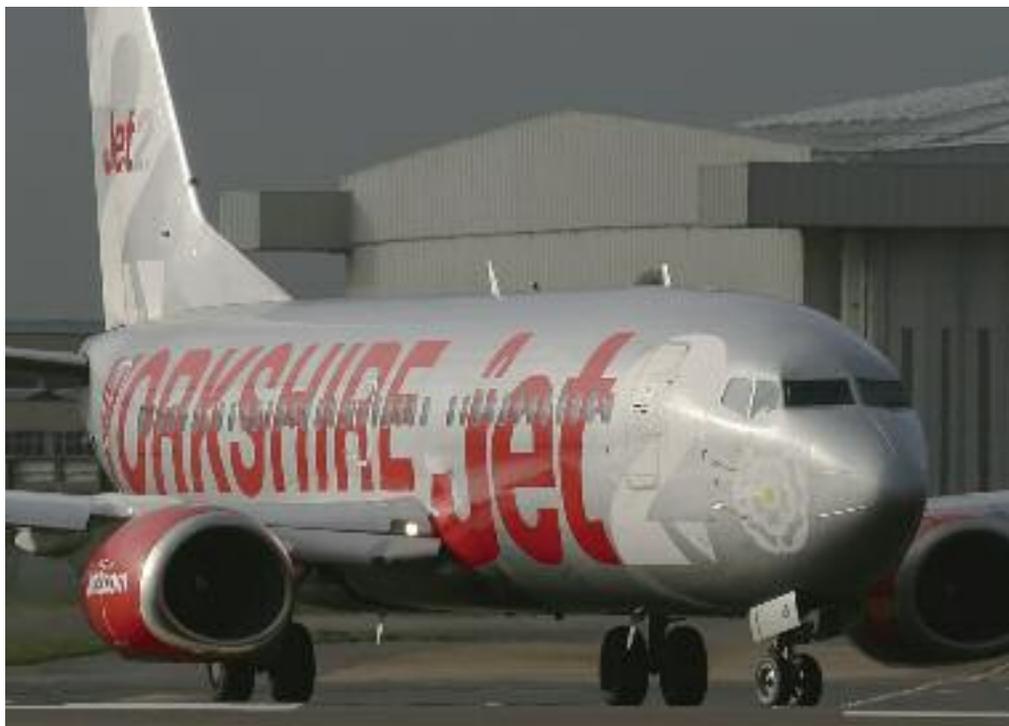
UK airline Jet2.com is one 737-300 operator that has taken the option to replace window belt skins on its fleet. This will prolong its useful life to 60,000-80,000FC.

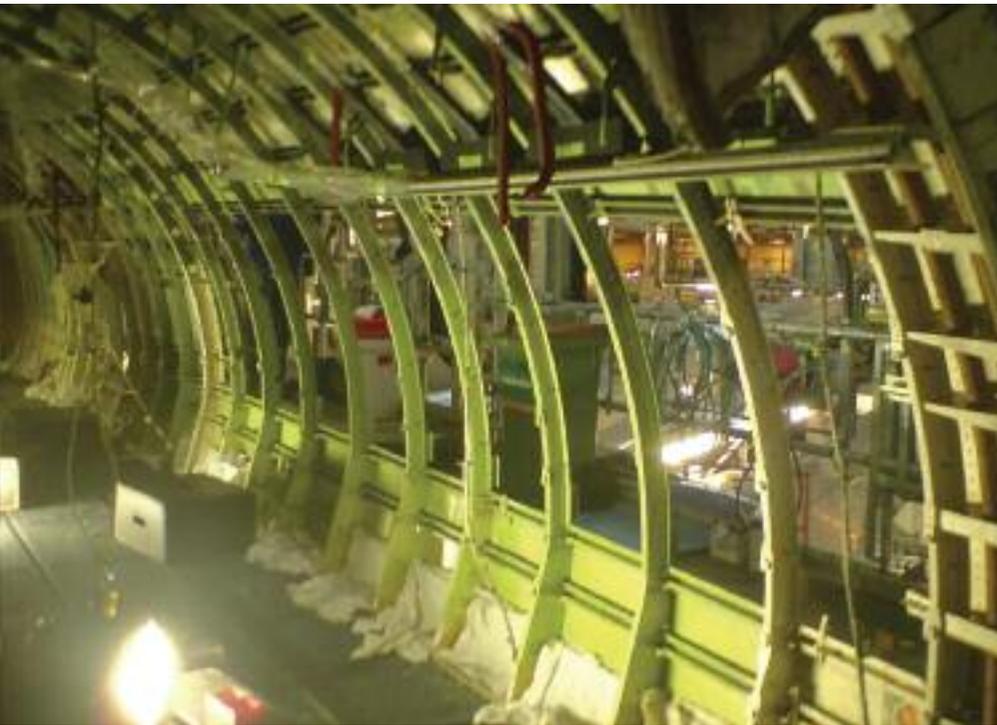
When all access, reinstallation, and aircraft jacking and rigging are considered, the window belt skin replacement, together with other appropriately combined heavy modifications, uses a total of about 5,500 man-hours. Together with the cost of new window belt skins, the whole modification costs about \$800,000 per aircraft.
