Engine maintenance involves several levels of shop visit workscope. Each stage of an engine shop visit has to be carefully planned so that the entire process can be completed in the shortest time. A detailed examination of every element of a full overhaul is made.

Analysing the engine shop visit process

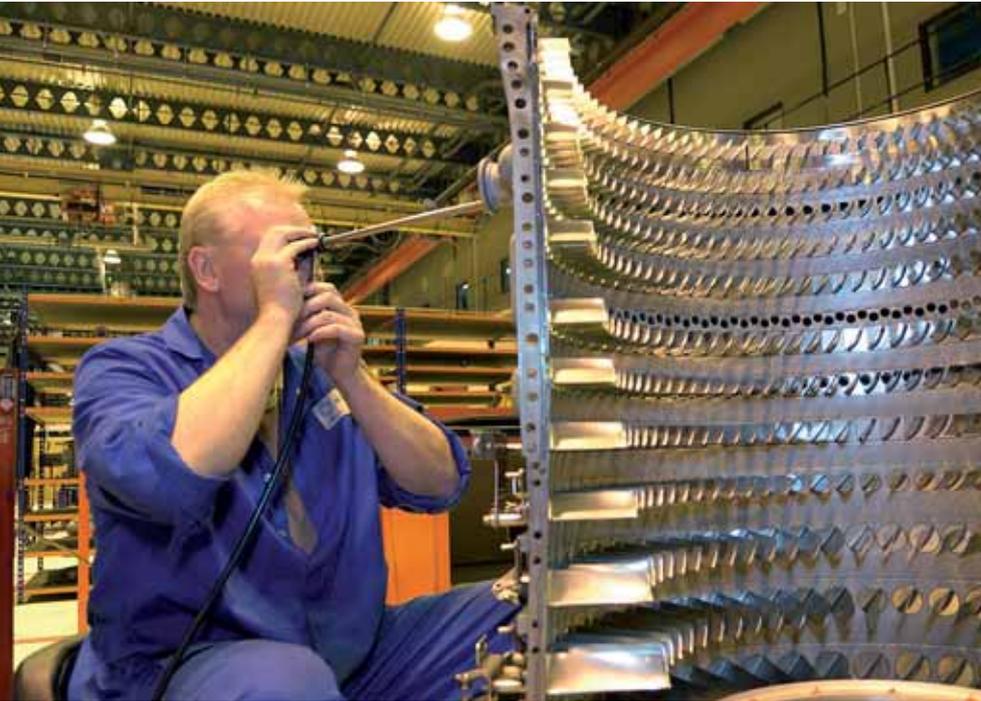
The HPC case consists of two halves. The rotor and stator can be ground simultaneously during reassembly to get the best blade and vane clearances.

is thinner here. Once blades are repaired their coating is reapplied before being inserted in the disks and drum," says Steenbock. "The LPC and blades are then ground down to the correct dimensions with a laser that measures the blade length to within a thousandth of a millimetre. First they grind the rotor blades and then the stator blades on the same machine, which completes the job with balancing in mind."

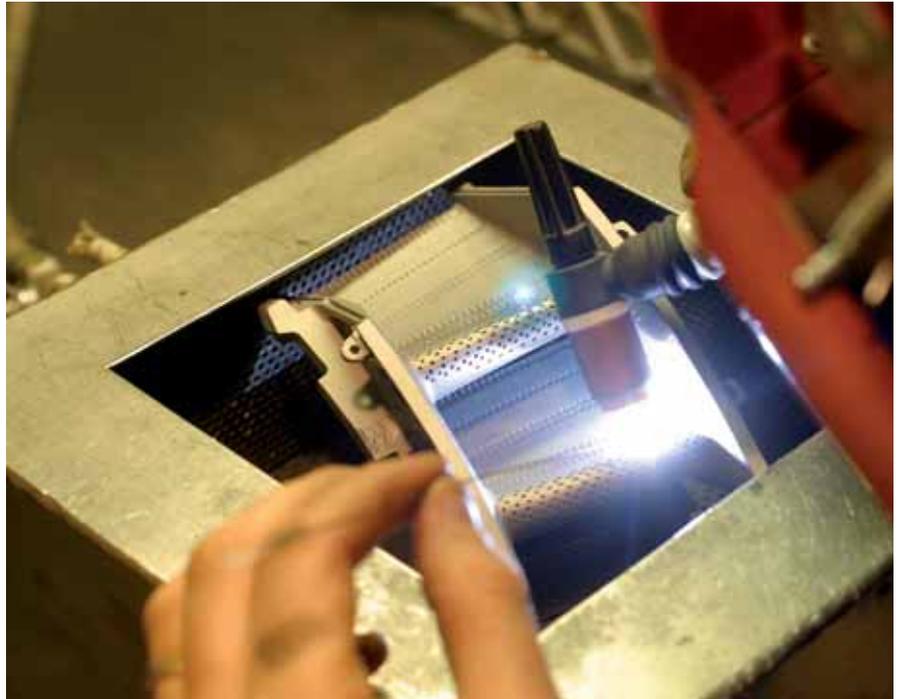
Like the HPC, the HPT can be divided into large and small parts. “Examples of large parts are the disks, shaft and cases, while the airfoils are small but high-cost parts. These are the nozzle guide vanes (NGVs) which are the stators and the rotating HPT blades. The HPT shrouds which seal the clearance

between the blade tips and inner wall of the case are also a major contributor to the material cost,” says Matthias Malina, vice president of engine parts and accessory repair at Lufthansa Technik. HPT modules either have one or two HPT stages, depending on the engine type, with a corresponding number of sets of NGVs, HPT blades and shrouds.”

Some Rolls-Royce engines have shrouds at the top of the HPT blades, and these join together to effectively form a ring. The top of these shrouds rub against a seal on the inner wall of the case.

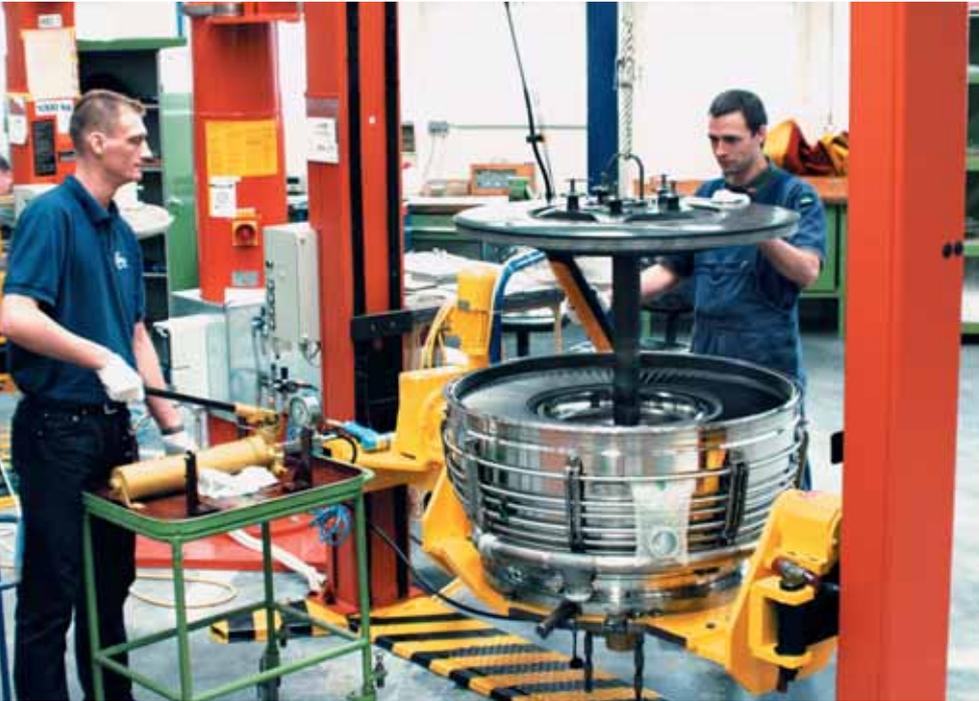
Reassembly of the LPT module is completed one stage at a time. Replacement honeycomb seals have a tight clearance with blade shrouds, so the LPT is rotated while closing the case.
