Hi-tech engine parts repairs: schemes & the economics

The repair of many engine components during shop visits involves high-technology (hi-tech) processes that restore the capability of engine components by utilising the latest welding and brazing techniques and coating technologies. Hi-tech repairs exist throughout the engine for all major engine types and their components, including the blades and vanes in every module, disc and shaft life limited parts (LLPs), casings, and combustion chambers. These repairs are now available for all modules and sections of each major engine type from several suppliers. The economic significance of hi-tech repairs is that they have the potential to save tens or hundreds of thousands of dollars in shop-visit costs. They have also contributed to preventing engine maintenance costs from increasing at a higher rate than has actually been experienced. More hi-tech repairs are constantly being developed and should contribute to further reductions in aircraft maintenance costs.

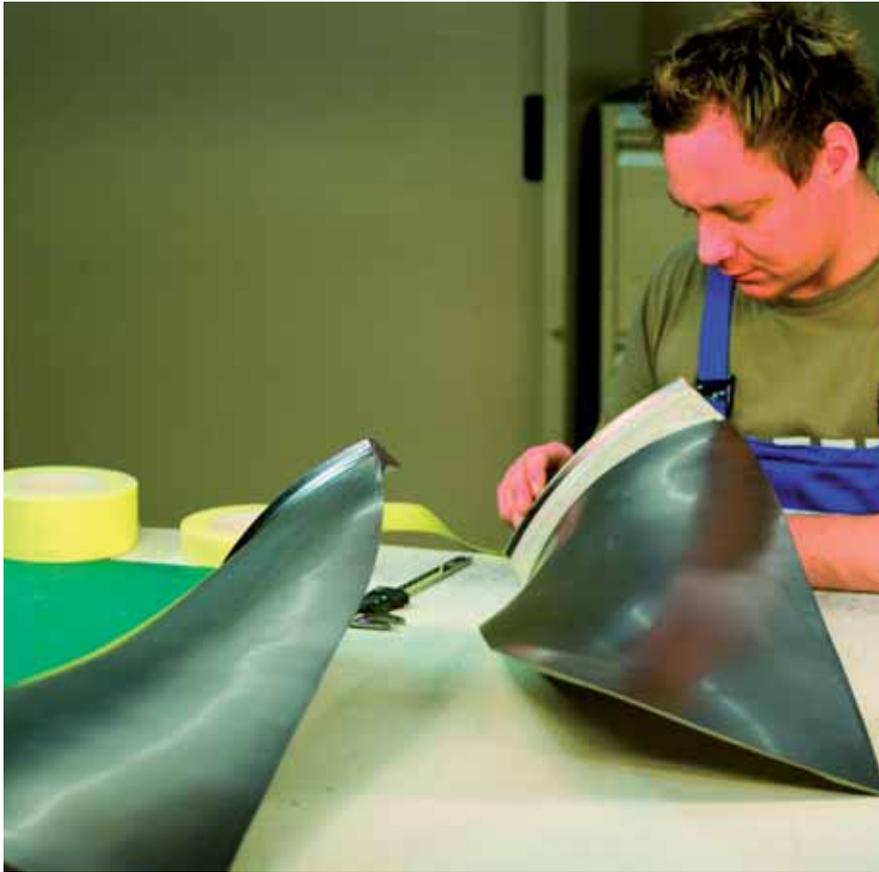
Repairs for the latest generation of fan blades, which use composites and carbon fibre, involve the use of a polymer fibre matrix.

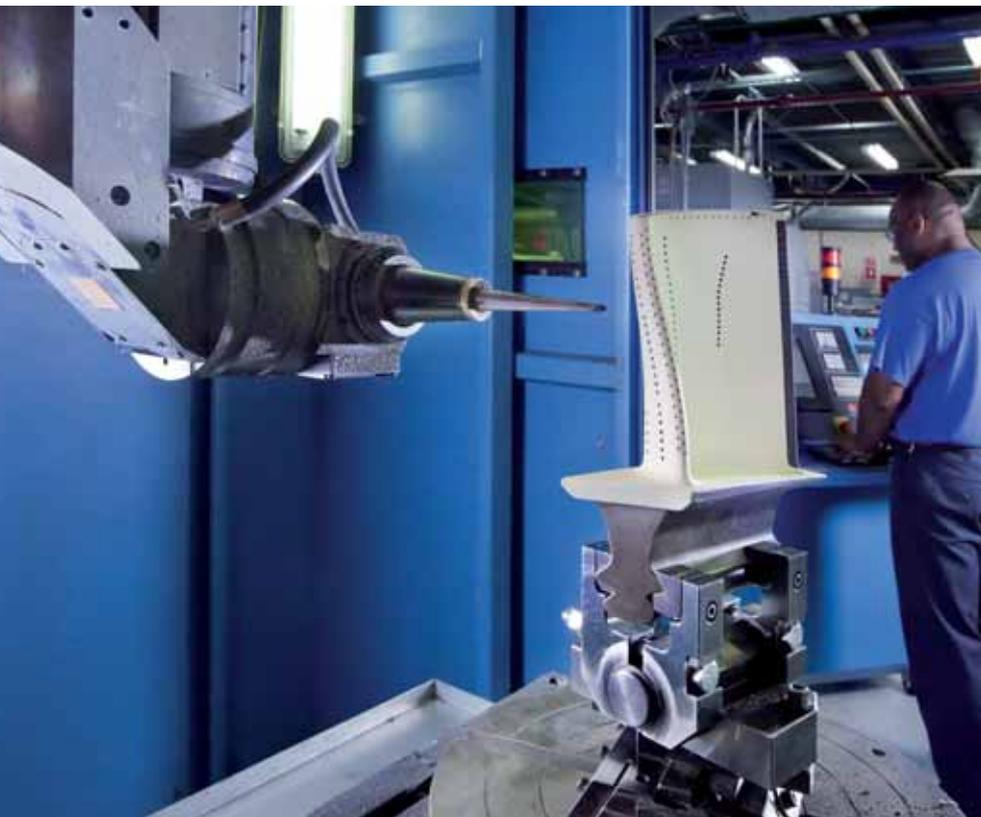
"LPC and HPC blade repairs are similar to those carried out for the fan blades," says Arendt. "We have developed an advanced recontouring process (ARP) for these blades, which

recontours the blades' leading edge profile and aerodynamic shape. The blade leading edges and chord width wear with engine operation, and the optimal leading edge contour and chord width is different for used blades compared to new airfoils."

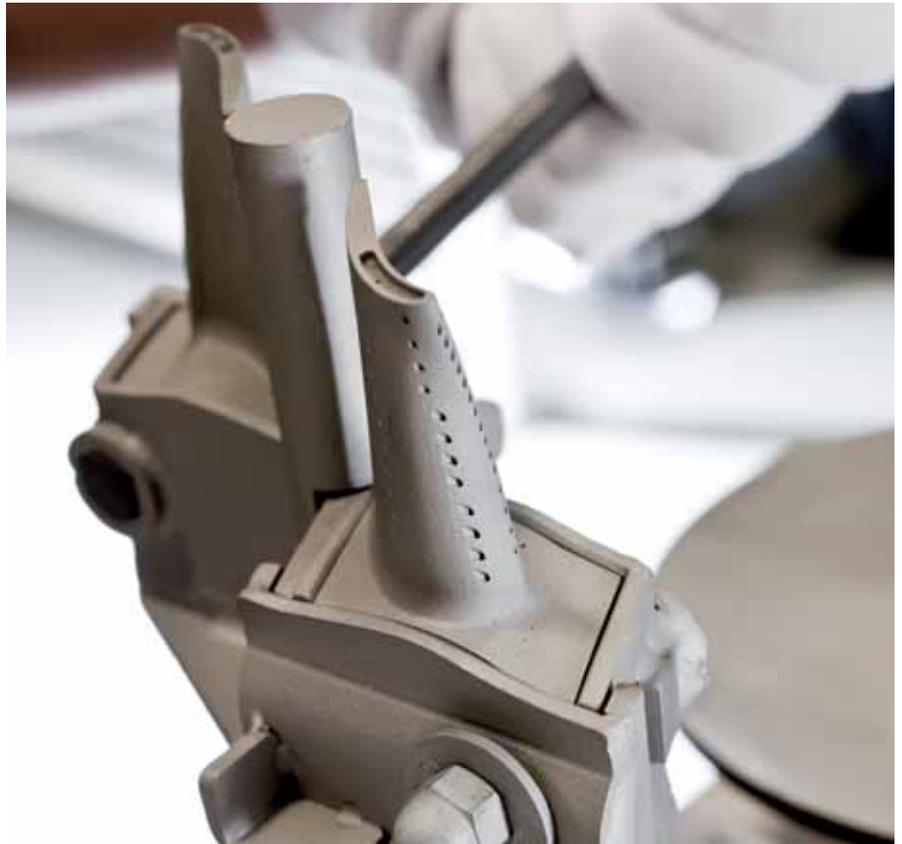
Chromalloy's HPT blade repairs are performed at its New York and Carson City, Nevada, facilities, where it has the

tooling to carry out ceramic coatings. "Care is required when repairing HPT blades, since there is a limit to the number of times that a full repair of the blade can be carried out, because stripping the thermal barrier coating reduces the thickness of the blade wall," says Church. "A full repair can therefore only be done once, but lighter repairs can be made several times. A light repair involves blade inspection and repair of cracks. A full repair involves complete stripping of the thermal barrier coating from the blade and a recoating it with new protective material. Typically, a light or rejuvenation repair will be made at the first shop visit, while a full repair will be carried out at the second shop visit. Another rejuvenation repair will usually be made on the blades at the third shop visit, before the blades are scrapped at the fourth shop visit."

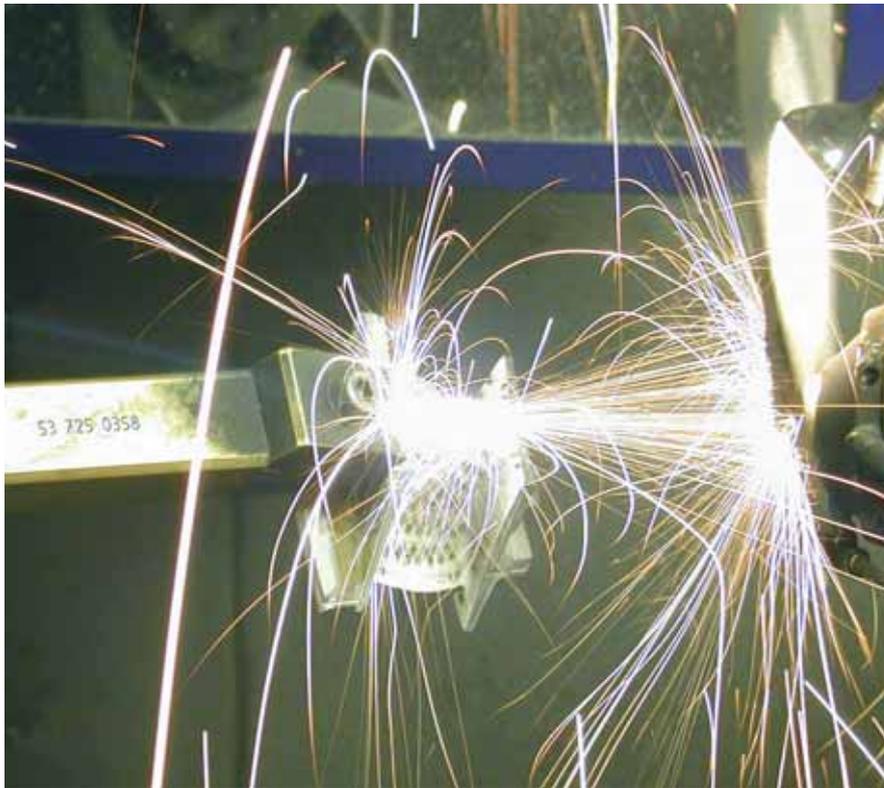
Laser drilling of cooling holes is one of the final stages in the repair of HPT NGV doublets. Along with HPT blades, repairs to these components derive some of the largest savings in engine maintenance.
