V2500 family modification & upgrade programmes

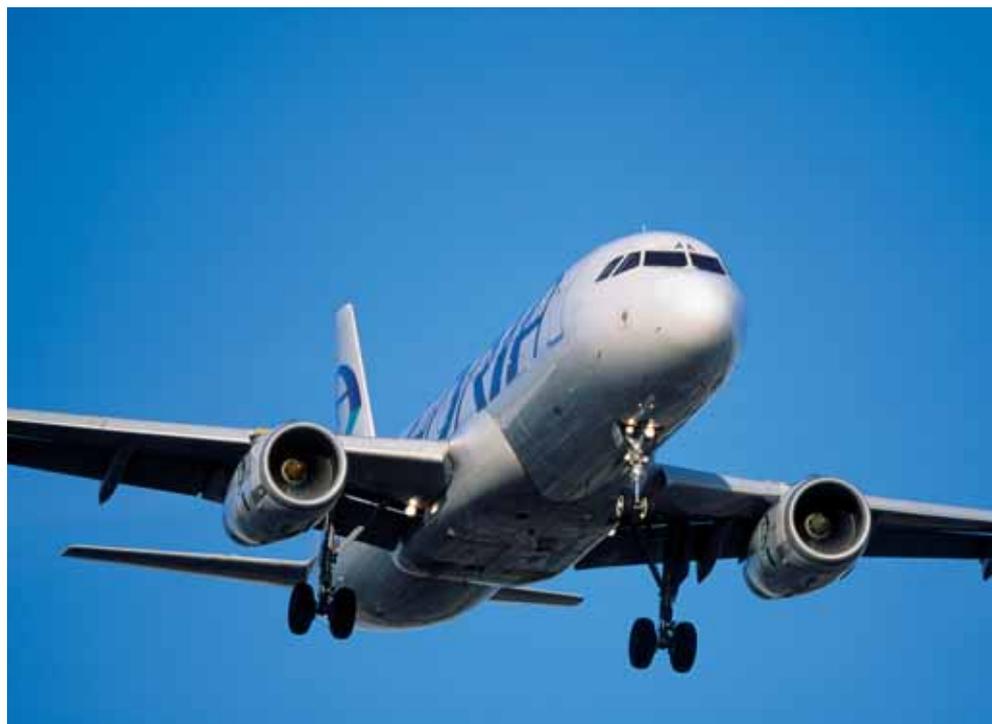
The V2500 has had relatively few problems with major ADs. The recently-certified SelectOne modification is a new build standard that is aimed at reducing fuel burn by about 1% and increase removal intervals by up to 20%.

The newest build standard of the V2500, SelectOne, was certified by the FAA in late 2007. It will become standard-build specification and enter service in the second half of 2008 on an IndiGo Airlines A320 following Airbus flight testing and certification.

The three-engine test programme suggests that SelectOne will: reduce fuel burn, and therefore carbon dioxide emissions, by 1%; improve time on-wing by 20%; add 12 degrees to the EGT margin; reduce miscellaneous shop visits by as much as 40%; and comply with the most stringent CAEP/6 NOx standards.

SelectOne modifications focus on the HPC, high pressure turbine (HPT) and low pressure turbine (LPT). The HPC has aerodynamic and mechanical modifications, elliptical leading edges on the blades and improved surface finish. The HPT has redistributed internal and film cooling, plus a minor restagger of the first stage for optimum cycle performance. There is a minor restagger of the LPT first stage.

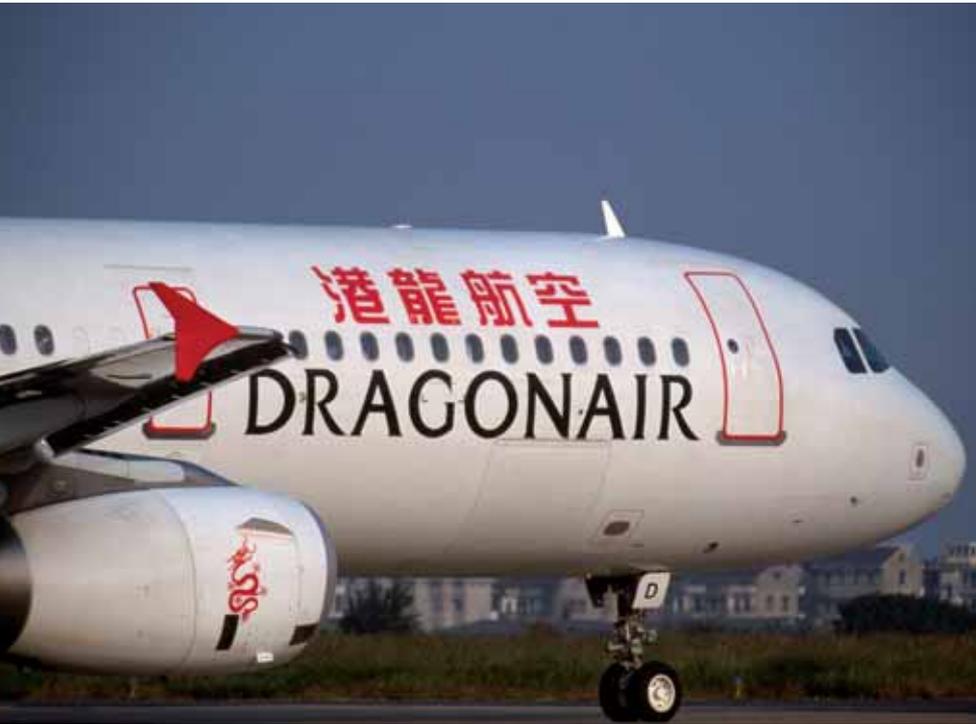
There are numerous small modifications for the V2500 that have gradually improved its performance and reliability since being introduced into service.
