High fuel prices mean that engine deterioration and the related rise in fuel consumption has begun to be considered as an issue in engine maintenance and overall engine management. The rate of fuel burn rise with accumulated time on-wing and overall engine costs should be analysed.

Engine deterioration & the rise in fuel burn

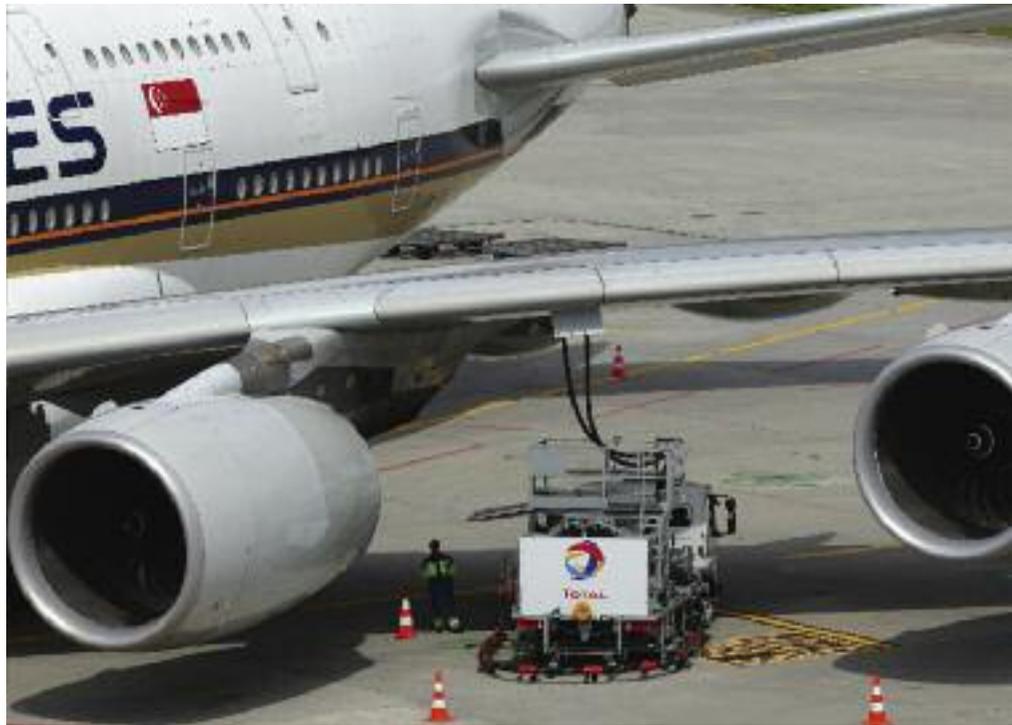
Blades wear in dimensions and aerodynamic curvature, and also crack.

“External factors are mainly related to the airline’s operating environment. Engine airfoils deteriorate at the highest rates in a sandy environment,” says Versteeg. “The abrasive effect of sand particles causes blade erosion, with respect to a change in both aerodynamic shape and blade dimensions. One particular issue in blade dimensions is the chord width of HPC blades, which reduces their ability to compress air.

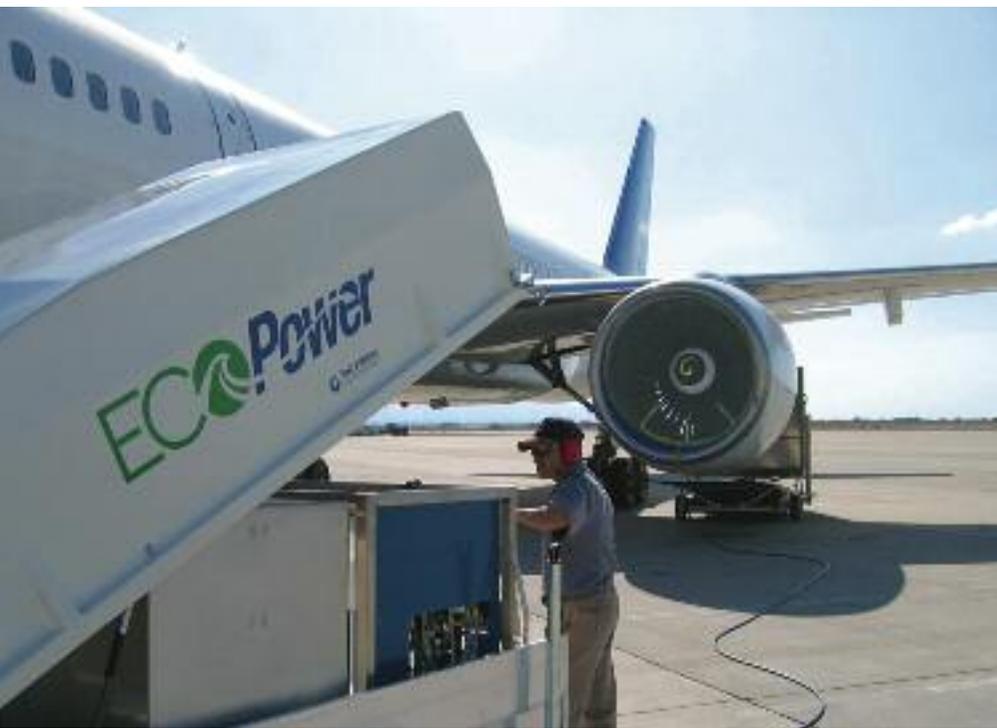
Regular water washing of engines helps keep airfoils clean and therefore maintain their aerodynamic efficiency. This in turn means throttle settings have to be increased at a lower rate with accumulated time on-wing, and so preserve an engine's rate of fuel burn.

Other operational techniques can be used to slow the rate of degradation and performance erosion. “Besides the usual recommendation of engine de-rate, the accumulation of dirt and grease on airfoils reduces performance and requires a higher throttle setting to achieve a particular level of engine thrust,” says Epstein. “Water washing has therefore become common among some operators. Our Eco wash at Pratt & Whitney (PW) can be used once every six months to reduce the rate of EGT margin erosion.

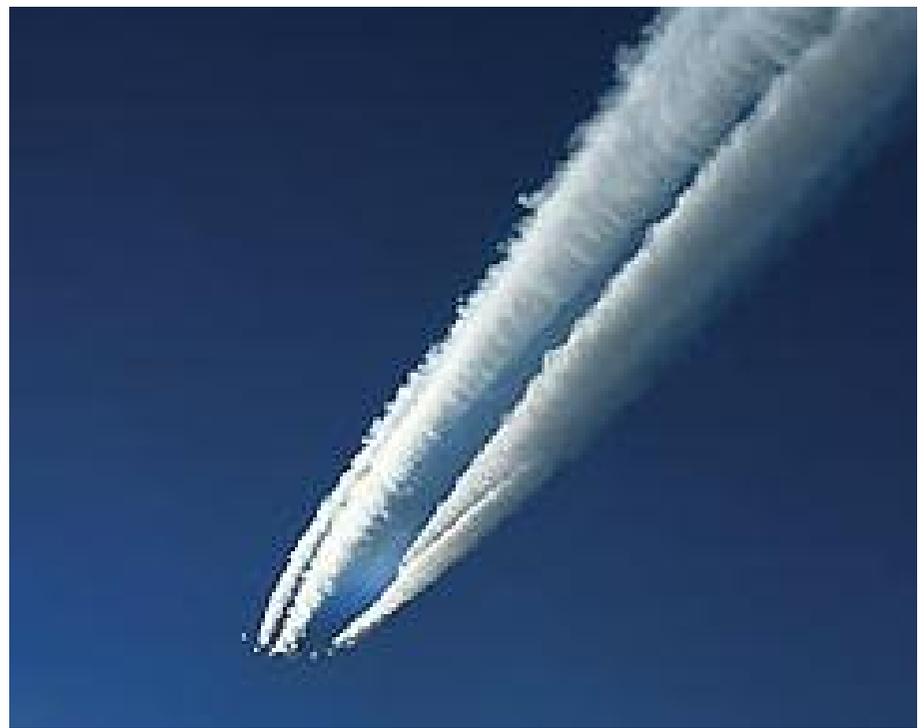
The rate of fuel burn rise can be 3-6% over the interval of an engine overhaul; the interval of two shops visits in the case of many engine types. Removing engines earlier for maintenance to avoid such a high increase may prove overall more economic than trying to maximise shop visit intervals.
